Report No. CETHA-BC-CR-89046

## Task Order 2 Enhanced Preliminary Assessment

TACONY WAREHOUSE  
PHILADELPHIA, PENNSYLVANIA

December 1989

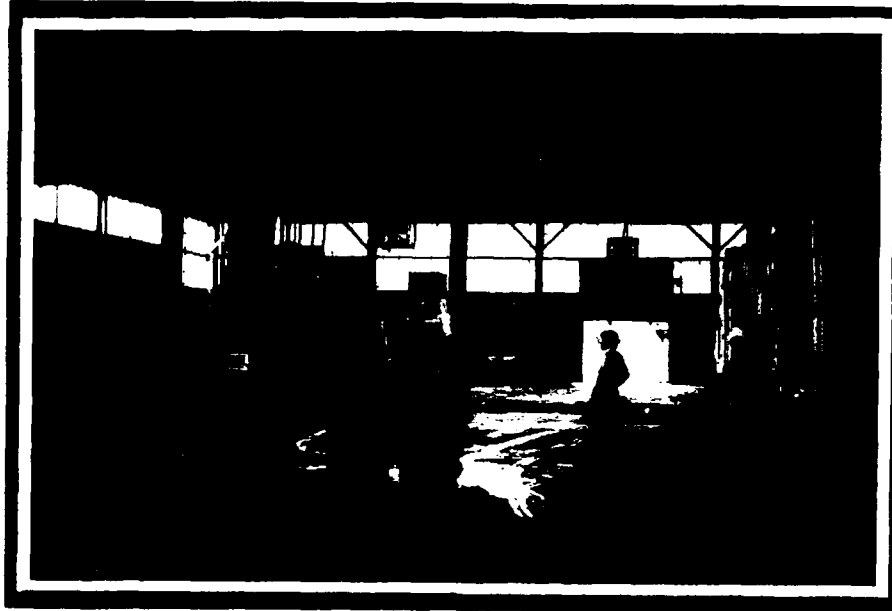
**1. INTERIOR OF BUILDING 461**

In 1966, TW was reported as excess. No resolution of the excess condition was made until 12 November 1970 when TW was assigned to the Army & Air Force Exchange Service (AAFES) while retaining accountability to the Frankford Arsenal [R-4]. AAFES utilized the warehouse for storing consumer products (e.g., clothing, housewares, and automotive equipment). Although motor oil and antifreeze were stored at TW, the containers within the pallets were never larger than 1 gal and any damaged cans were quickly contained for use onsite. On 24 June 1976, accountability for TW was transferred to Fort Dix pending the closure of the Frankford Arsenal. AAFES vacated the facility on 23 November 1987 [R-4]. TW remained vacant for four months until the New Cumberland Army Depot entered into an agreement with Fort Dix, which expires 21 April 1993, to use TW for the storage of items such as unused containers, office furniture, and spare equipment parts (photo 1). TW history is presented as a timeline in Table 2-2.

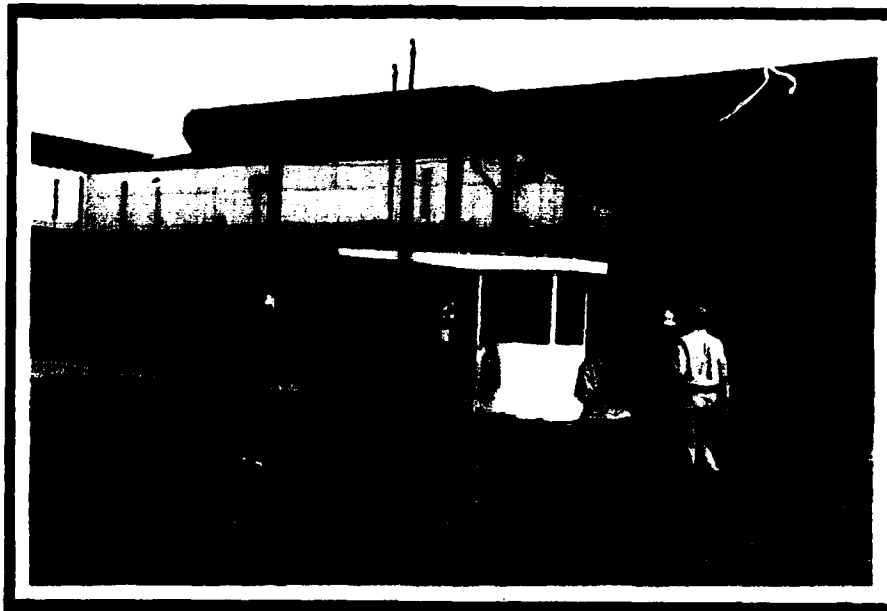
**2. FUEL PUMPS AND UNDERGROUND FUEL TANK AREA  
(IN BERMED AREA AT LEFT)**

Three 10,000-gal capacity fiberglass tanks are buried inside the former spray pond [T-8; R-15]. The two southernmost tanks (photo 2) were installed in 1972 and originally contained diesel fuel and gasoline. The easternmost tank was switched from gasoline to diesel service in 1987. The northernmost tank (photo 3) was installed in 1974 and contained No. 2 heating oil. This tank has underground piping leading to the boiler room in the southwest portion of Building 460. These tanks have not been leak tested since their installation [T-8] and are believed to contain only residual amounts of fuel [R-8].

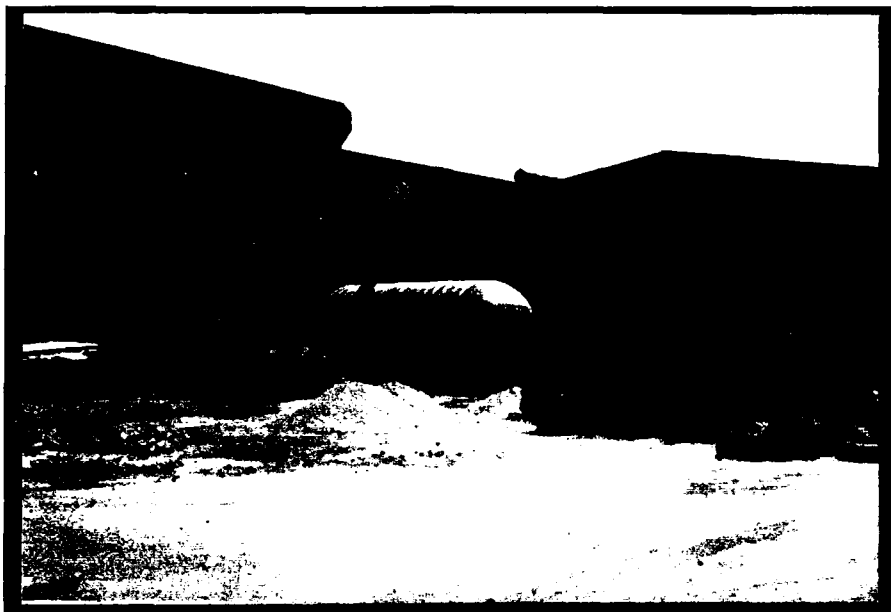
**3. 10,000-GALLON FIBERGLASS TANK DURING  
INSTALLATION, 15 MAY 1974**

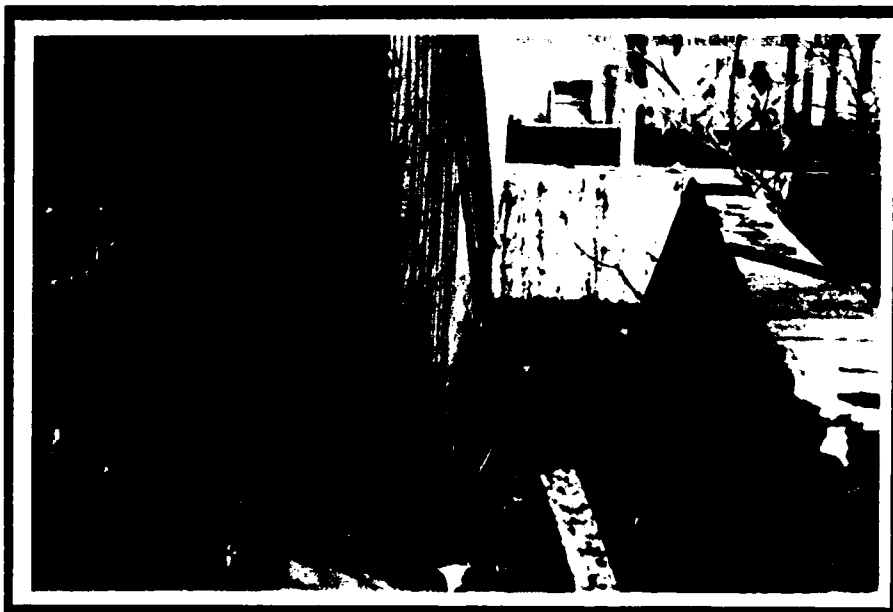
**6. CLOSE-UP OF 9,000-GALLON TANK SHOWING  
RUST AND PEELING INSULATION**

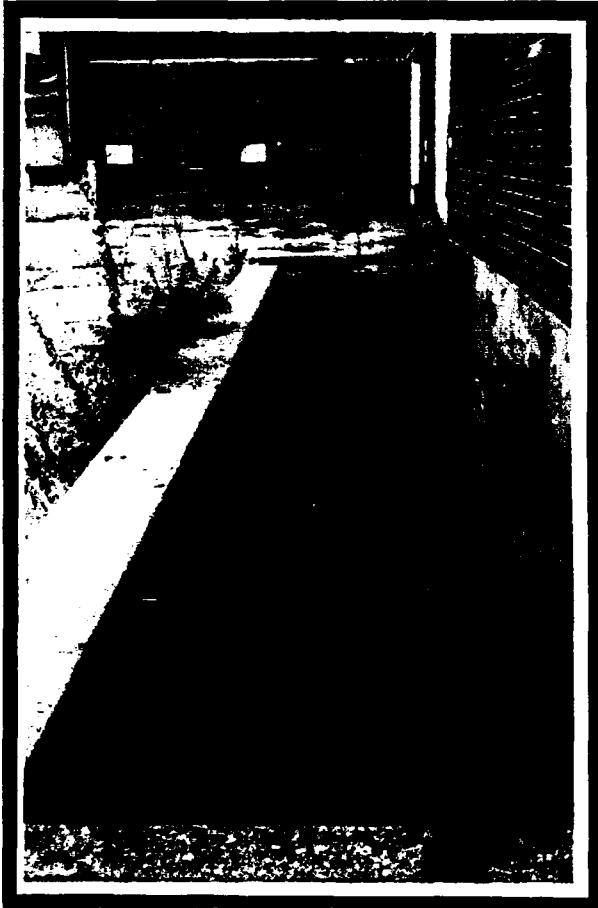
The footings at the bottom of the two basement stairwells west of Building 461 (photo 7), which appear to be remnants from previous tanks, are in fact part of previously removed air conditioning condenser units [T-8].

**7. LOCATION OF FORMER AIRCONDITIONING  
CONDENSER**

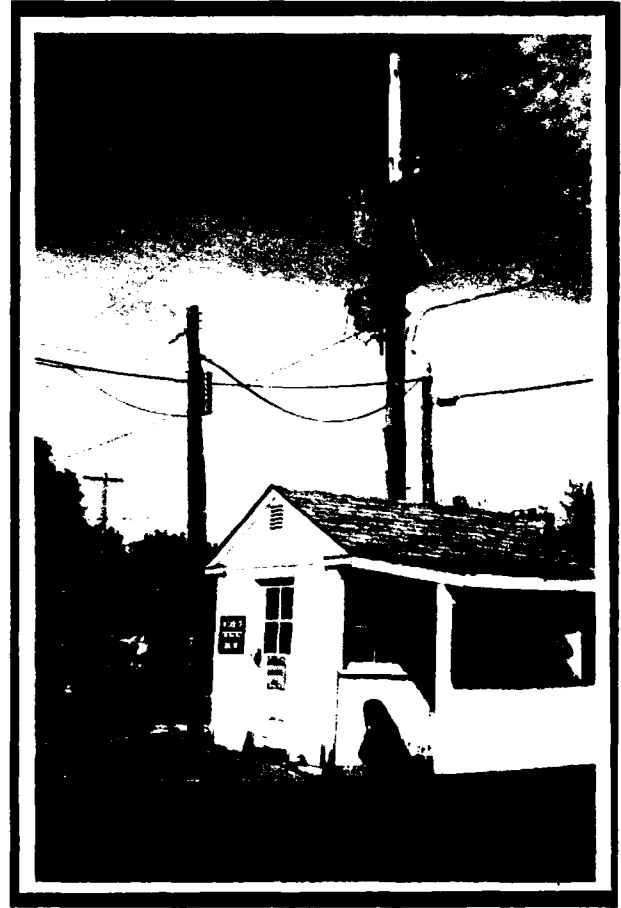
Immediately north of the main warehouse, pesticides, herbicides, and rodenticides were stored in a former transformer substation building. The two active transformer substations, as well as the electrical switchgear in Building 467, had their dielectric fluid replaced in the early 1980s, but have never been tested for PCBs. The two pole-mounted transformers along Princeton Avenue are suspected to contain PCBs.

**8. TWO POLE-MOUNTED TRANSFORMERS  
ABOVE NORTH SENTRY POST**
